Manhole Inspection Summary

Manhole # S69K__017MH

Insp Date: **1/28/08 2:07 PM**

Location Address: **6722 Fait Ave.**

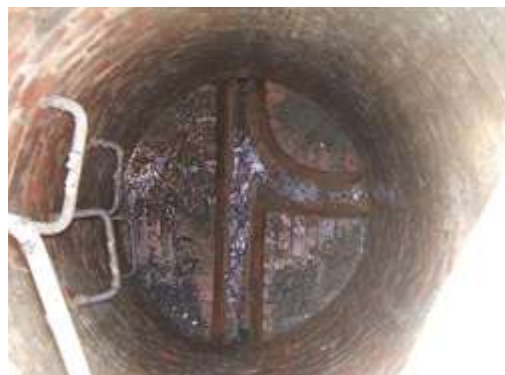
Top View

O12 top of picture

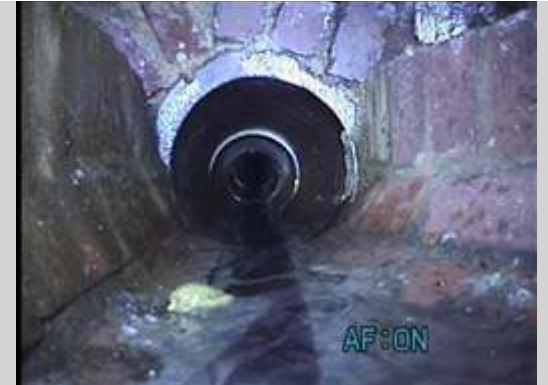
12 O'Clock Outflow

10 in. Circular Gravity Sewer
Pipe Out @ 12 O'Clock

Pipe Height: **9.6** (in.) Rod and Bar (Angled)
Pipe Material: **Clay** ☐ Pipe Lined
Invert Depth: **9.92** (ft.) Flow Characteristics: **Slow**
Deposits: ☒ None ☐ Mud ☐ Sludge ☐ Debris ☐ Grease
Silt Depth: (in.) Deposits Extent:
Infiltration: **None** Pipe Seal Cond: **Sound**

Connects To: **Manhole**

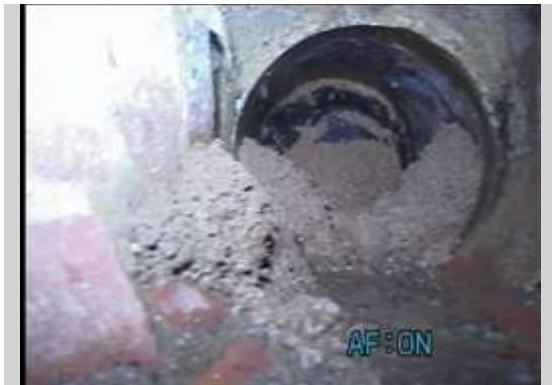
3 O'Clock Inflow

8 in. Circular Gravity Sewer
Pipe In @ 3 O'Clock

Pipe Height: **8.4** (in.) Rod and Bar (Angled)
Pipe Material: **Clay** ☐ Pipe Lined
Invert Depth: **9.71** (ft.) Flow Characteristics: **None**
Deposits: ☐ None ☐ Mud ☒ **Sludge** ☐ Debris ☐ Grease
Silt Depth: **0.25** (in.) Deposits Extent: **Light**
Infiltration: **None** Pipe Seal Cond: **Sound**

Connects To: **Stub connection / abandoned**

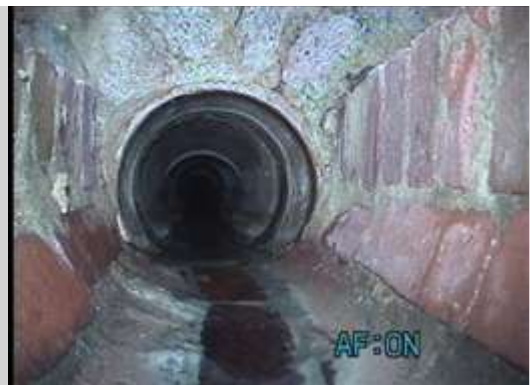
6 O'Clock Inflow

8 in. Circular Gravity Sewer

Pipe In @ 6 O'Clock

Pipe Height: **8.4** (in.) Rod and Bar (Angled)

Deposits: ☒ None ☐ Mud ☐ Sludge ☐ Debris ☐ Grease

Infiltration: **None** Pipe Seal Cond: **Sound**
